**Flood Control Project Maintenance
Levee Inspections**

Maintenance Issue Types Only, Levee Inspection Report By Mile - Spring 2017

Reclamation District No. 0341 Sherman Island

Waterway	Bank	Unit Miles	Inspection Start/End	Inspector
Unit No. 01 Threemile Slough	Right	3.36	04/07/2017 04/07/2017	Herman Phillips

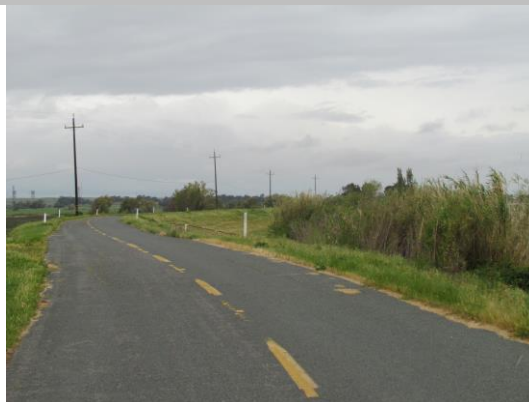
Photo 1 of 1 : SP_2017_RD0341_167_20_20170510_00047.jpg

LM Start	0.00	Rating **	M	Issue No.	20
LM End	0.03	Issue Type +	Ma	Location *	WS
Category	Earthen Levee		GPS Latitude/Longitude		
			Start	End	
Item	Vegetation		38.085555 °	38.085918 °	
			-121.686438 °	-121.686690 °	
DWR ID	DWR_RD0341_01_f_2016_20				
Comment Code					
V1 : Control annual grass and weeds on the levee slopes and easements.					
Inspector Comment					
Control the regrowth on the waterside..

RD 341 Looking downstream from crown roadway levee mile 0.00.

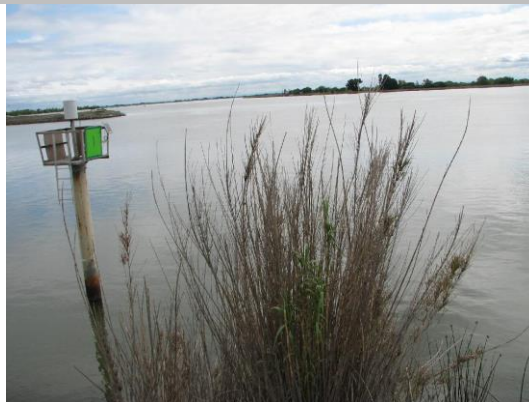
Photo 1 of 3 : UCIP_SP_2017_22063_37640.jpg

Comment Code					
Inspector Comment					
FS_ID:22063 DS_ID:24215 EP_NO: N/A Repair Type: Non-Urgent Crossing Status: Found UCIP Comments: Dense vegetation limits the inspector's visibility to identify signs of pipe failure (leaks) along the slopes. Recommend removing vegetation along pipe alignment to conduct proper inspection of structure and appurtenances. FIELD_STRUCT_DESC: 30-inch steel drainage pipe through the levee, 11.1 feet below the crown. CM cutoff wall around pipe at center of levee. Siphon breaker on both sides. Pump on landward side approximately 300 feet from landward toe. Pipe exposed on both levee slopes. Rock revetment on waterward slope. (USACE-1962). This entry matches the Drainage or Irrigation Structure referenced in O&M manual (HLM 0.0). Marine Station number 1 located on waterward side with attached small solar panel on top. FS Date: 5/5/2009

Marine station posts in river identified as Station 1 near crossing.

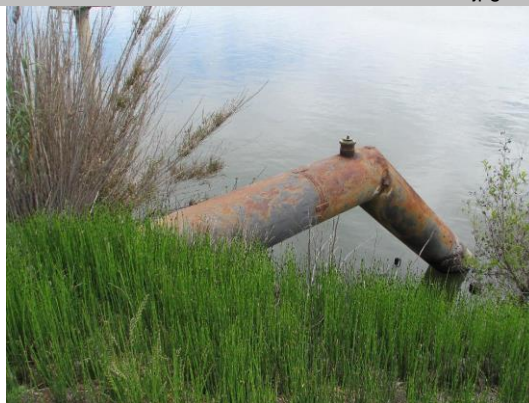
Photo 2 of 3 : UCIP_SP_2017_22063_37644.jpg

View of pipe and siphon breaker located on waterward side--dense vegetation on slope.

FS_ID:22063
DS_ID:24215
EP_NO: N/A
Repair Type: Non-Urgent
Crossing Status: Found
UCIP Comments: Dense vegetation limits the inspector's visibility to identify signs of pipe failure (leaks) along the slopes. Recommend removing vegetation along pipe alignment to conduct proper inspection of structure and appurtenances.
FIELD_STRUCT_DESC: 30-inch steel drainage pipe through the levee, 11.1 feet below the crown. CM cutoff wall around pipe at center of levee. Siphon breaker on both sides. Pump on landward side approximately 300 feet from landward toe. Pipe exposed on both levee slopes. Rock revetment on waterward slope. (USACE-1962). This entry matches the Drainage or Irrigation Structure referenced in O&M manual (HLM 0.0). Marine Station number 1 located on waterward side with attached small solar panel on top.
FS Date: 5/5/2009

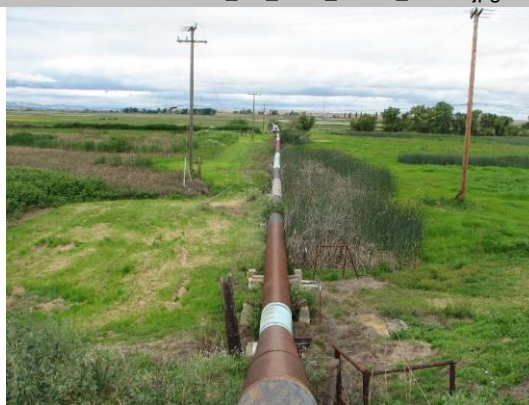
Photo 3 of 3 : UCIP_SP_2017_22063_37642.jpg

Overview of landward slope above ground once it exits levee. Pump is located approximately 300 feet from levee toe.

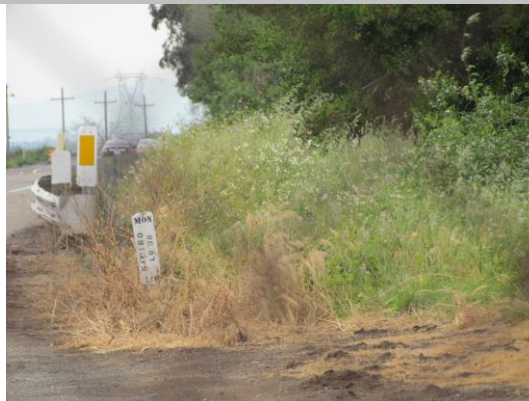
Photo 1 of 1 : SP_2017_RD0341_168_41_20170510_00083.jpg

LM Start	3.94	Rating **	U	Issue No.	41
LM End	6.14	Issue Type +	Ma	Location *	WS
Category	Earthen Levee			GPS Latitude/Longitude	
				Start	End
Item	Vegetation			38.098158 °	38.080223 °
				-121.706320 °	-121.730312 °
DWR ID	DWR_RD0341_02_s_2017_41				
Comment Code					
V2 : Remove the wild growth other than native grasses from the levee slopes.					
Inspector Comment					
Remove the unwanted vegetation from the waterside shoulder and slope.

Looking downstream from levee mile 3.94 at tall unwanted weeds and other vegetation on the waterside shoulder and slope.

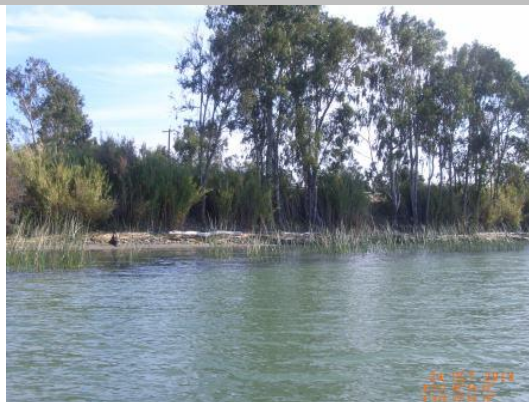
Photo 1 of 1 : SP_2017_RD0341_168_7_20170404_00004.jpg

LM Start	4.15	Rating **	M	Issue No.	7
LM End	4.19	Issue Type +	Ma	Location *	WS
Category	Supplemental			GPS Latitude/Longitude	
				Start	End
Item	2015 USACE Erosion Survey, DRAFT			38.095148 °	38.094590 °
				-121.706367 °	-121.706393 °
DWR ID	DWR_RD0341_02_s_2016_7				
Comment Code					
Inspector Comment					
2011 - Large new erosion pocket probably hidden by vegetation in the past. 2015: No observed changes. [2015 Site ID: SAC_8-2_L]

USACE 2013 Photo #1

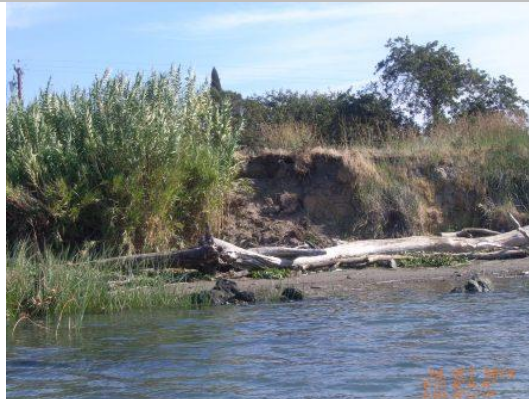
Photo 1 of 1 : SP_2017_RD0341_168_3_20170404_00002.jpg

LM Start	4.47	Rating **	U	Issue No.	3
LM End	4.62	Issue Type +	Ma	Location *	WS
Category	Supplemental			GPS Latitude/Longitude	
				Start	End
Item	2015 USACE Erosion Survey, DRAFT			38.090620 °	38.088572 °
				-121.706684 °	-121.707127 °
DWR ID	DWR_RD0341_02_s_2016_3				
Comment Code					
Inspector Comment					
1999 - New small slump in eroded bank. 2005 - Reach extended because of vertical bank along the roadway upstream. 2011 - More slumping since last year. 2012 - Site upgraded to critical. Very steep slope which may be effecting the highway on top of the levee. 2015: New erosion towards downstream end of site. [2015 Site ID: SAC_8-0_L]

USACE 2013 Photo #1

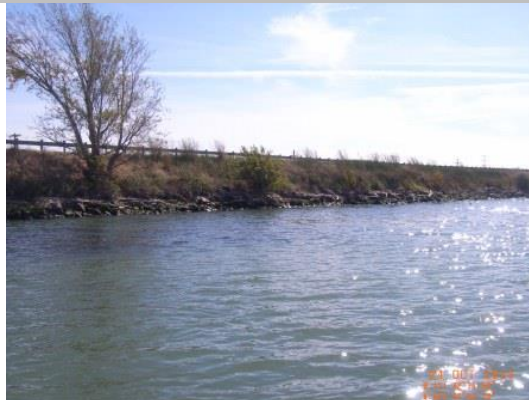
Photo 1 of 1 : SP_2017_RD0341_168_4_20170404_00003.jpg

LM Start	4.76	Rating **	U	Issue No.	4
LM End	4.85	Issue Type +	Ma	Location *	WS
Category	Supplemental			GPS Latitude/Longitude	
				Start	End
Item	2015 USACE Erosion Survey, DRAFT			38.086603 °	38.085459 °
				-121.707786 °	-121.708607 °
DWR ID	DWR_RD0341_02_s_2016_4				
Comment Code					
Inspector Comment					
2011 - Large slump section. 2012 - Site extended downstream, upgraded to critical, severe windwave. Slope is very steep and may be effecting the highway on top of the levee. 2015: No observed changes. [2015 Site ID: SAC_7-9_L]

USACE 2013 Photo #1

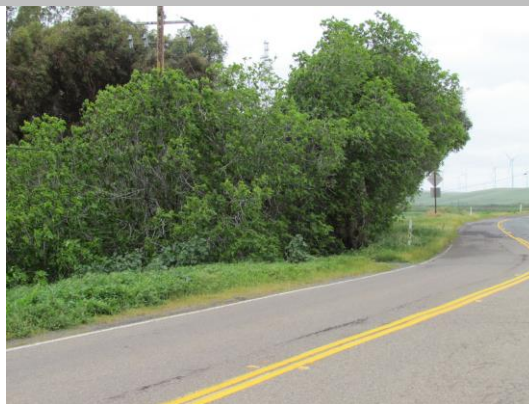
Photo 1 of 1 : SP_2017_RD0341_168_47_20170516_00085.jpg

LM Start	6.29	Rating **	U	Issue No.	47
LM End	6.32	Issue Type +	Ma	Location *	LS
Category	Earthen Levee			GPS Latitude/Longitude	
				Start	End
Item	Trim / Thin Trees			38.081075 °	38.081142 °
				-121.732813 °	-121.733465 °
DWR ID	DWR_RD0341_02_f_2015_47				
Comment Code					
T1 : Trim trees to at least five feet above ground level.					
Inspector Comment					
Remove the Fig trees or trim them up five foot from the ground so the levee slope can be inspected.

RD 341 landside levee slope mile 6.29-6.32.

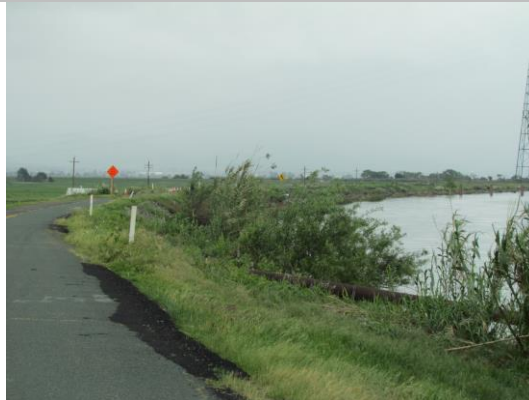
Photo 1 of 1 : SP_2017_RD0341_168_48_20170516_00086.jpg

LM Start	8.49	Rating **	U	Issue No.	48
LM End	8.65	Issue Type +	Ma	Location *	WS
Category	Earthen Levee			GPS Latitude/Longitude	
				Start	End
Item	Vegetation			38.070060 °	38.068387 °
				-121.766982 °	-121.768978 °
DWR ID	DWR_RD0341_02_f_2016_48				
Comment Code					
V1 : Control annual grass and weeds on the levee slopes and easements.					
Inspector Comment					
Control the growth of Bamboo from the waterside slope.

RD 341 Waterside slope looking downstream from levee mile 8.49-8.65
bambo present on the slope.
